## 加古川 1 RHにおける下部槽寿命の改善\*

### Improvement of Campaign Life of No.1RH Lower Vessel in Kakogawa Works

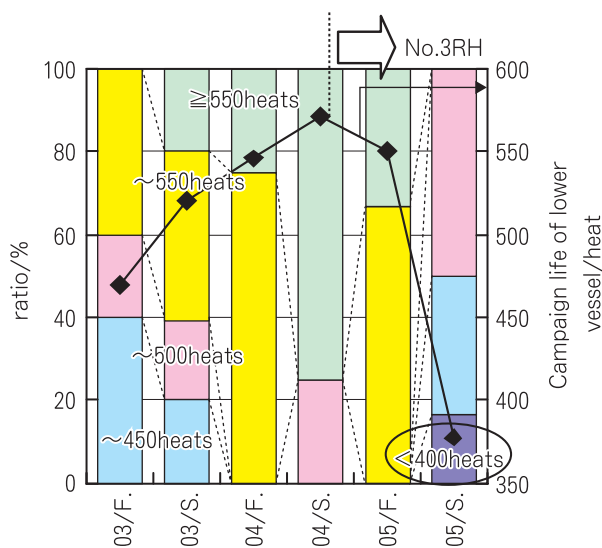
このような操業条件の大きな変化に伴い、No. 1 RHでは槽底れんがの損傷や環流管れんがの異常損傷が原因になって、下部槽寿命が大幅に低下した。Fig. 3 にNo. 1 RHにおける下部槽寿命の推移を示す。側壁れんがの材質改善や昇熱時の送酸量管理により、No. 1 RHの寿命は500chまで増加していた。しかし、No. 3 RHの稼働に伴い下部槽寿命の低下が始まり、'05年/下期では450chに満たずに停炉するケースがある。従来は下部槽のもっとも損傷が大きな部位は側壁であったが、現在では槽底と環流管れんがの損傷がもっとも大きくなっている。そこで、その損傷状況と原因について、従来からの変化点を中心に調査を行った。<sup>1), 2)</sup>

With such a great change in the service conditions, the campaign life of the lower vessel has decreased because of bottom brick wear and unusual throat brick wear in No.1RH. The change in campaign life of the lower vessel of No.1RH is shown in Fig.3.

By improving the sidewall brick material and controlling the amount of O<sub>2</sub> blowing during heatup, the campaign life of No.1RH was increased to 500heats. However, after the start of No.3RH operation, it has started to decrease, and in second half of '05, there were some cases that end within 450heats. Formerly, the most critical wear area of the lower vessel was the sidewall, but now, is the

Fig. 3 Change in campaign life of the lower vessel in No.1RH.

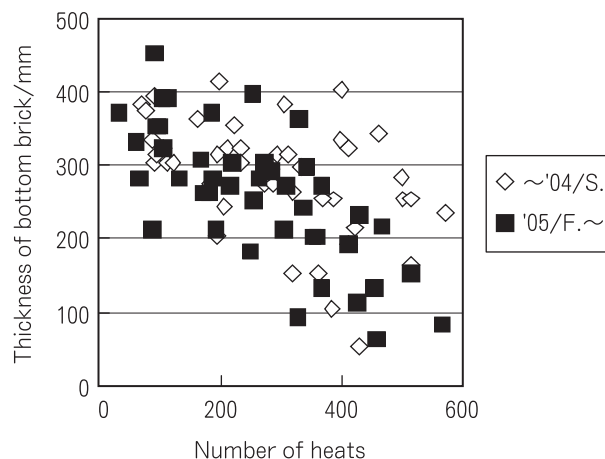
ごとに測定した下部槽槽底れんがの残厚を示している。Fig. 4 のデータは、No. 3 RH稼働前の'04年下期と稼働後の'05年上期の2種類からなっている。槽底れんがの残厚は、トラブル防止の観点から、下部槽稼働の最後で100mm以上を確保することになっている。従来と比較して3 RH稼働後の'05年上期は、槽底れんがの損傷速度は全体的に大きくなっている。また、これまでも停炉までに槽底れんがの残厚が100mm以下となるケースは発生しているが、その発生頻度は以前よりも高くなっている。圧入補修材、槽底れんがそれぞれについて損傷速度を調査したところ、いずれについてもNo. 3 RH稼働後の損傷速度は以前よりも増加していることが確認できた。

Fig. 4 Change in bottom brick thickness with No.3RH operation.

The change in bottom brick thickness with the number of heats is shown in Fig.4. Each point on the graph shows the thickness of the bottom bricks, which was measured during the snorkel change. The data in Fig.4 consists of two types, data during the second half of '04 before the start of No.3RH operation and data during the first half of '05 after start. The thickness of the bottom brick is required to be at least 100mm at the end of lower vessel campaign for trouble free operation. Compared with the former level, the wear rate of the bottom bricks in the first half of '05 is quite rapid. There are some cases where the thickness of the bottom bricks falls below 100mm by the end of each term. The frequency is higher than before. Investigation of the wear rate of pressure

槽底れんがおよび圧入材の損傷速度が大きくなった原因としては、①処理時間の増加に伴い槽底および環流管れんがの損傷が大きくなっていること、②稼働率の低下に伴う温度変化により、スポーリング損傷が発生していることが考えられる。まずは、応急的な対応として、圧入補修のスパンを短縮した。従来、浸漬管耐火物の寿命となる約100chを目安に、浸漬管交換と併せて圧入補修を実施してきた。しかし現在は、オペレーターが各チャージ処理後に圧入材の残存状況を目視確認し、状態が良くなければ、浸漬管の状況に関係なく補修する体制をとり、トラブル防止を図っている。恒久対策としては、槽底れんがの材質をマグクロレンがから耐スポーリング性に優れるマグカーボ

The reason for the increase in the wear rate of the bottom bricks and pressure grouting refractory material is thought to be ① Increase in treatment time causes severe wear of the bottom and throat leg, ② Spalling as a result of temperature changes caused by decrease in heats per day. At first, as a temporary measure, the grouting repair span was shortened. As usual, grouting repair was carried out during snorkel exchange, depending on the snorkel life of almost 100heats. But now, the condition of the grouting material is observed after every treatment by the operators, and if the condition is bad, grouting repair is carried out regardless of the snorkel condition, in order to avoid trouble. As a permanent measure, the material of the bottom brick will be changed from magnesia-chrome to magnesia-carbon, in the future to decrease spalling damage. The change in bottom brick thickness after the improvements is shown in Fig.5. With these improvements, the thickness of the bottom brick remained over 100mm until the end of the lower vessel life.

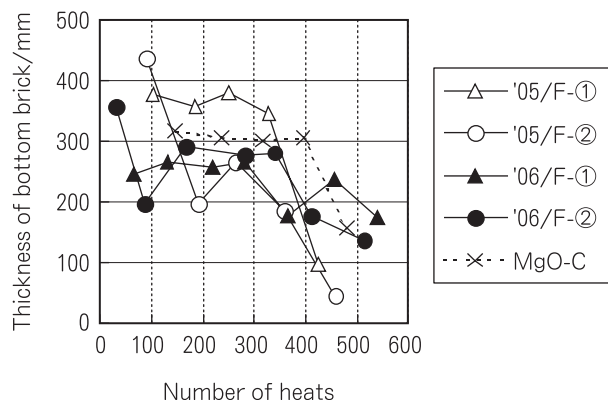
Fig. 5 Change in bottom brick thickness at No.1RH.

ンれんがに変えることである。改善実施後の槽底残厚の推移グラフをFig. 5に示す。これらの改善により、下部槽の停炉まで残厚100mmを確保することが可能になっている。

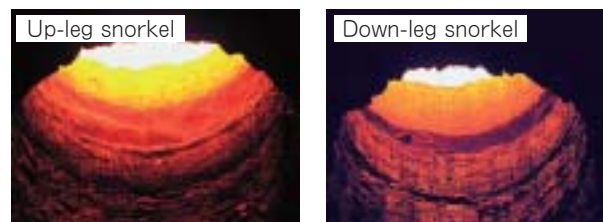
Fig. 6に環流管れんがの損傷による槽底鉄皮穴あきトラブル発生時の、環流管れんがの損傷部位外観を示す。鉄皮の穴あき位置は上昇側環流管と槽底鉄皮との接合部分であった。さらに、亀裂は下降側環流管のれんがにも半周に渡って認められた。それらはまた、激しく損傷されていた。

Fig. 6 Appearance of damaged throat brick.

The appearance of the damaged throat bricks, that caused the perforation of the bottom shell, is shown in Fig.6. The perforated area was the part connecting the upleg snorkel with the bottom shell of the lower

vessel. Furthermore, a crack extended half-way around the throat bricks in the downleg snorkel. They were also severely damaged.

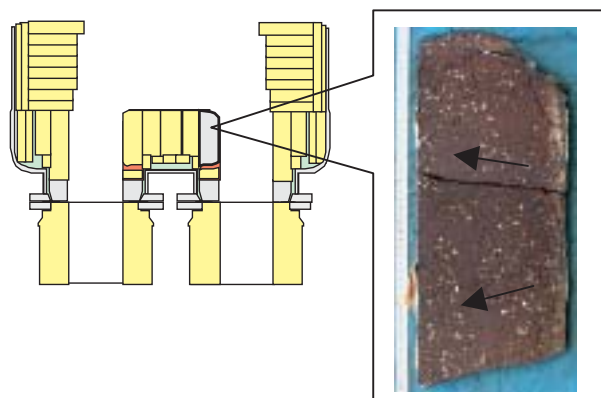
そこで損傷の程度と原因を探るべく、停炉後の下部槽の調査を行った。まず、下部槽の敷きれんがの状況を観察したところ、まったく損傷していないことがわかった。敷きれんがを解体していくと、上昇管から下降管にかけて、槽底の鉄皮とれんがの間に地金差しが認められた。そこで、環流管れんがの損傷部位を詳細に調査した。損傷された環流管れんがの切断面をFig. 7に示す。れんがには、稼働面から背面にかけ、いくつかの亀裂が発生している。それらの亀裂の方向は稼働面に垂直ではなく、また、互いに平行でもない。このことより、環流管れんがに何らかの応力が生じて亀裂が発成し、続いて、その亀裂に溶鋼が侵入し、終には、鉄皮穴あきが起こったと考えられる。

Fig. 7 Cross section of damaged throat brick.

In order to investigate the degree of damage and cause, we carefully examined the lower vessel after service. At first, the bottom brick condition of the lower vessel was observed and found not to be damaged at all. As the bottom brick is demolished, the finning was found between bottom shell and bottom brick, from upleg to downleg. So, damaged throat brick was examined in detail. The cross section of a damaged throat brick is shown in Fig.7.

In that brick, there are some cracks from the hot face to the cold face. They are not normal to the hot face, and they are not parallel to each other. From these results, it seems that, some stress occurred in the throat bricks causing the cracks, and then, steel invaded the cracks and the shell was perforated.

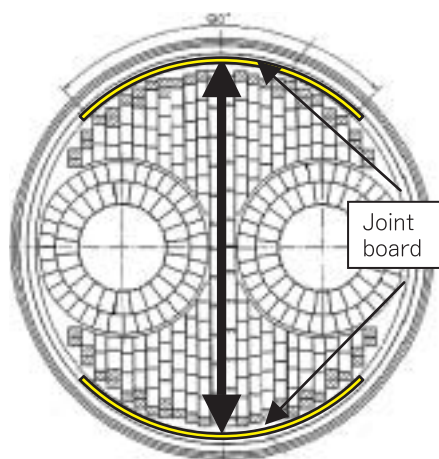
まず、現状の槽底ライニングにおいては、環流方向の膨張吸収率が約50%であるのに対し、反環流方向は37%しかないことが明らかになった。この膨張吸収率に明確で妥当な指標はないが、低すぎると敷のれんがが膨張でせり上がり、これにより環流管れんがの背面側が引上げられて引張応力を生成すると考えられる。そこで、膨張代を改善する目的で、Fig. 8に示すように、敷部のウェアれんがと側壁パーマれんが間に可撓性ボードを設置した。膨張吸収率は環流方向で63%に改善ができた。

Fig. 8 Expansion allowance of bottom brick.

In the usual bottom brick lining, it was revealed that the expansion allowance in the circumferential direction is almost 50%, and that in the other direction is only 37%.

Though there is no determined correct amount for this expansion allowance, it seems that low allowance causes the bottom bricks to bulge up and the cold face of the throat brick is pulled up causing tensile stress. Therefore, in order to improve the expansion allowance, a joint board was set between the wear bricks and the safety lining bricks of the sidewall in the bottom area as shown in Fig.8. The expansion allowance ratio of circumferential direction improved to 63%.

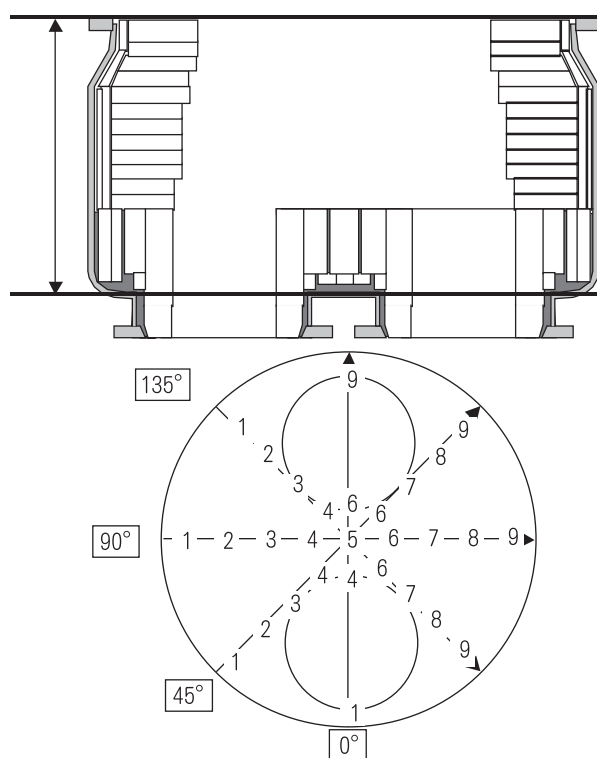
Fig. 9 Measured deformation of the bottom shell after steel shell replacement.

to assess the deformation of the steel shell bottom quantitatively, displacement of the bottom shell after each campaign was measured. The procedure used for measuring the deformation were the distance from the top of the vessel to the shell bottom, in four directions, for nine points, as shown in Fig.9.

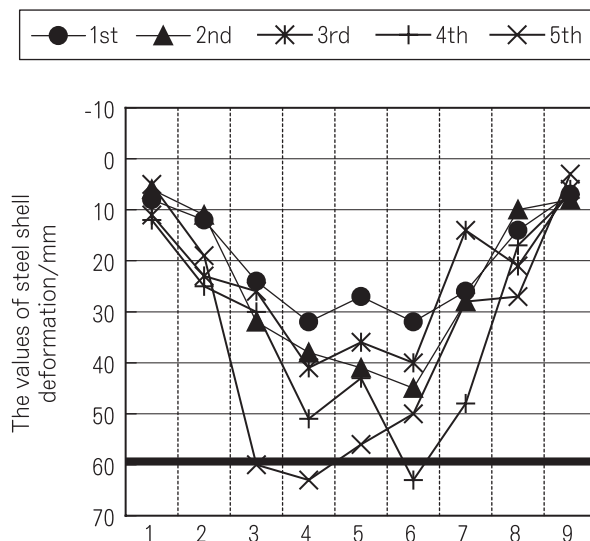
示すように、4方向、各9点（0°部分は5点）について測定する方法を採用した。測定データの一例をFig.10に示す。縦軸は鉄皮図面寸法からの変形量を、横軸は槽底の測定点を示している。変形量は槽ごとに異なるが、この鉄皮においては2炉代の使用で、槽底部分が約45mm変形している。そこで、この鉄皮の変形に関する応急的な措置として、槽底鉄皮の変形限界値を設定し、60mmと

Fig.10 Measured deformation of the bottom shell and limit deformation level.

An example of measured data is shown in Fig.10. The axis of ordinate shows the measured displacement from the dimensional plane of the steel shell, the axis of abscissa shows the measured point of the bottom. As the deformation level differs among vessels, there exists about 45mm deformation of the bottom part of this steel shell after two campaigns. As a temporary measure for this deformation of the steel shell, a deformation level limit of 60mm was set because, over the past several years, there have been some troubles of steel shell deforming over 60mm which demanded steel shell renewal.

した。それは、過去数年に渡って、鉄皮変形が60mm以上の場合に鉄皮更新が必要になるトラブルが多く発生したからである。最良の対策は、鉄皮材質に応じた鉄皮変形量の管理を行うことである。これまでは下部槽鉄皮の材質として、SS400を使用していたが、クリープ変形を抑える目的で、耐クリープ特性に優れた材質を適用することとした。新鉄皮材質の変形挙動をFig.11に示す。従来の材質と比べて、1炉代での変形量絶対値が少なく、またその後の使用でも変形がほとんど進行していない。その結果、鉄皮を更新する際は、この耐クリープ鋼を適用することにした。

The best countermeasure is to control steel shell deformation so the material of the shell was checked. Usually, the material of the shell was SS400, but in order to reduce the creep deformation, we chose a material that has creep resistance. The deformation behavior of the new shell material is shown in Fig.11. Compared with the former material, the deformation after one campaign is small, and there is little deformation progress after several campaigns. Therefore, we decided to use creep resistant steel in the case of shell renewal.

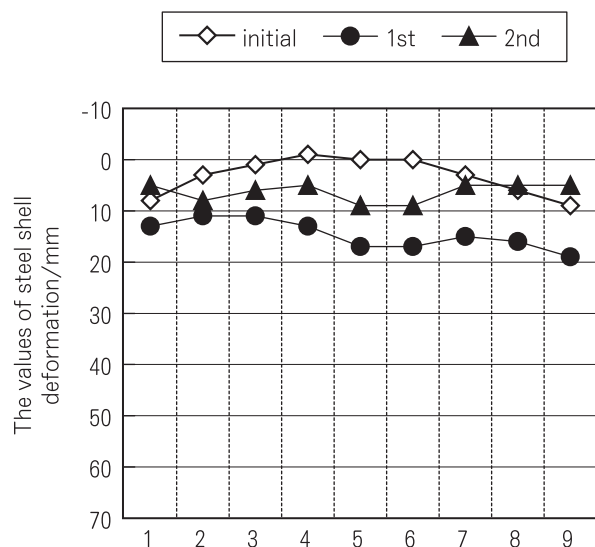
Fig.11 Measured deformation of the improved bottom shell.

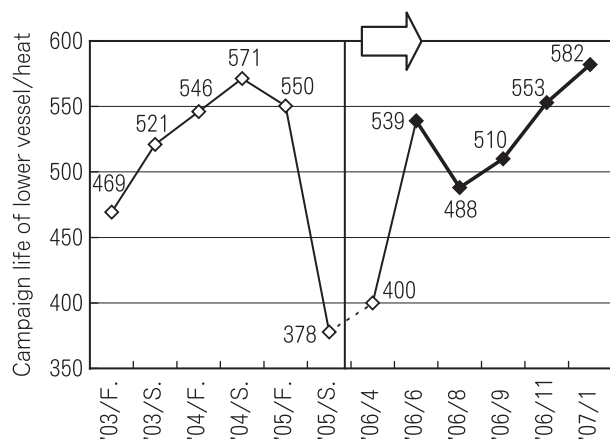
以上の各種改善を実施してきた結果、Fig.12に示すように、下部槽寿命は従来レベルまで回復した。そして、問題部分の損傷は減少し、トラブルによる突発停炉も低減することができた。

As a result of above-mentioned actions, the campaign life of the lower vessel returned to the original level as shown in Fig.12, and the wear of the problem parts was decreased and sudden shut down by trouble has reduced.

Fig.12 Change in campaign life of lower vessel at No.1RH.
