# SHINAGAWA TECHNICAL REPORT

## 転炉MHPの損傷形態の調査と 高靱性化技術適用

Investigation of MHP Wear Pattern for BOF  
and High Fracture Toughness Type MHP

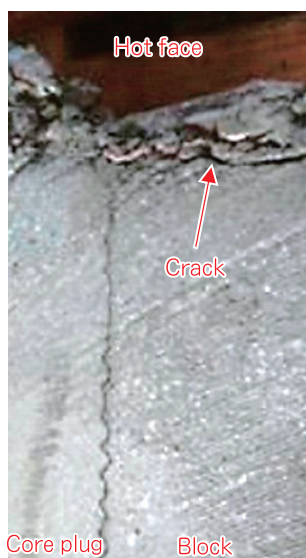
Fig. 3 Cut section of used large mono-block MHP.

転炉羽口の稼働面は溶鋼からの受熱により高温に曝される一方で、耐火物内部は高流速の吹き込みガスによって冷却される。このため、耐火物内に生じる温度差(温度勾配)が大きくなり、耐火物は強い熱応力を受ける。また、溶銑装入時には急激な温度変化が起こり、待機時にもガス吹きを行い冷却されている羽口は、極めて大きい熱衝撃を受けることとなる。これらの熱応力により、羽口耐火物の内部に亀裂が発生、伸展し、断続的な剥離を引き起こしていると考えられている<sup>3)</sup>。実際に転炉で使用された大型MHPの使用後切断面写真をFig.3に、MHPの一般的な損耗パターンを示した図をFig.4に示す。MHPの損傷要因としては稼働面の溶損、吹き込みガスによって起こる溶鋼摩耗、未溶解スクラップによる機械的摩耗、周囲の炉底れんがからの迫りによる機械的応力など、様々な要因があげられるが、Fig.4に示されるように階段状の残厚減少を示すことが多く、大きな残厚の落ち込みはFig.3で見られる稼働面からやや内部に発生する亀裂に起因した熱スポーリングでもたらされるものと考えられる。また、Fig.3では

The smooth residual thickness reduction period observed in Fig. 3 is considered attributable to thermal spalling in the vicinity of the hot face. It was hypothesized according to microstructure observation, which will be described in the next section.

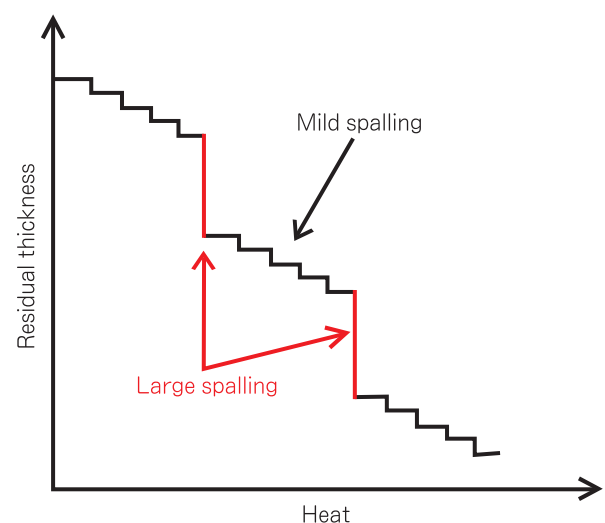
Fig. 4 General wear pattern of MHP.

While the hot face of a converter tuyere is exposed to the high temperature of molten steel, the inside of the refractory is cooled by the high flow velocity of gas. Therefore, the temperature difference, or gradient, occurring in the refractory becomes large, and the refractory receives strong thermal stress during steel refining. In addition, a sudden change in temperature occurs when the molten iron is charged, and the tuyere, through which cold gas is blown even during standby, receives extremely large thermal shocks. Thus, it is believed that due to those thermal stresses, cracks develop and propagate inside tuyere refractories, causing intermittent peeling<sup>3)</sup>. The cut section of a MHP used in an actual converter and the general wear pattern of the MHP are shown in Figs.3 and 4, respectively.

稼働面近傍においても亀裂の発生が認められ、比較的滑らかに残厚減少する区間においても微視的にみると、微小剥離が連続的に起こることにより残厚減少が進行しているものと考えられる。つまり、MHP内に発生する大きな温度勾配に起因する稼働面からやや内部に発生する亀裂や稼働面近傍での微小剥離により主に損傷が進行していると推定される。

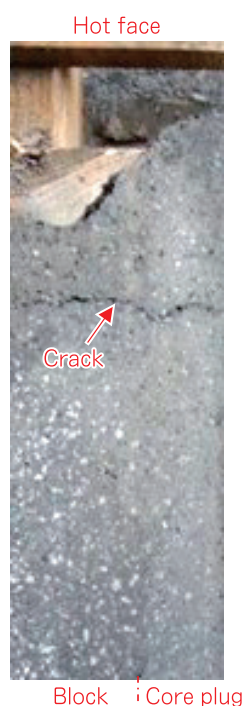
Fig. 5 Cut section of used MHP.

前項で述べたMHP内に生じる温度勾配に起因する熱スポーリング損傷の調査のため使用後MHPの稼働面微構造組織を反射顕微鏡で観察した。観察したMHPは芯体、ブロックとも添加物として金属Al、Siを含む一般的な不焼成MgO-Cれんがである。実際の転炉で約3ヶ月間閉塞することなく使用されたMHPを回収し切断加工して顕微鏡観察用試料を準備した。MHPの使用後の切断面写真をFig.5に示す。切断面において芯体から

ブロックにかけて稼働面に平行な亀裂が生じている。稼働面のステンレスパイプ間を拡大観察した写真をFig.6に示す。稼働面表層3mm付近に表層剥離に繋がる稼働面に平行な亀裂の発生が認められた。

approximately 3 months in an actual converter without clogging and a sample was collected for microscopic observation and prepared by cutting. The cut section is shown in Fig. 5. A crack parallel to the hot face can be observed from the core plug to the block in the cut section. The microstructure between pipes in the vicinity of the hot face is shown in Fig. 6. A fine crack parallel to the hot face at 3mm distance from the hot face can be observed.

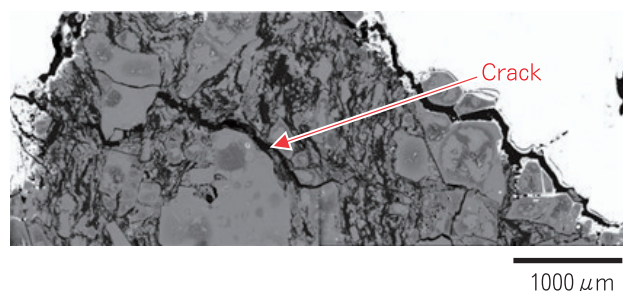
Fig. 6 Microstructure between pipes of used MHP.

また稼働面近傍5mm程度でステンレスパイプが溶融している様子が観察され、少なくとも稼働面から5mm以内では稼働中に約1400℃以上の高温となっていたものと思われる。一方、それよりも内部ではパイプが未溶融のまま残存していたことかられんが稼働面近傍までガス冷却効果が及んでいることが示唆され、稼働面表層3mmおよび内部に剥離に繋がる稼働面に平行な亀裂の発生が認められたことから、れんが稼働面近傍では温度勾配が大きい状態であったと推察された。

Since a melted stainless pipe was observed within 5mm from the hot face, it is thought that the range within 5mm from the hot face was heated to 1400℃ or higher during service. In the same sample, the melted pipe was not observed at the range more than 5mm from the hot face. Fine cracks parallel to the hot face were recognized. This is evidence that a large thermal gradient occurred at that region.

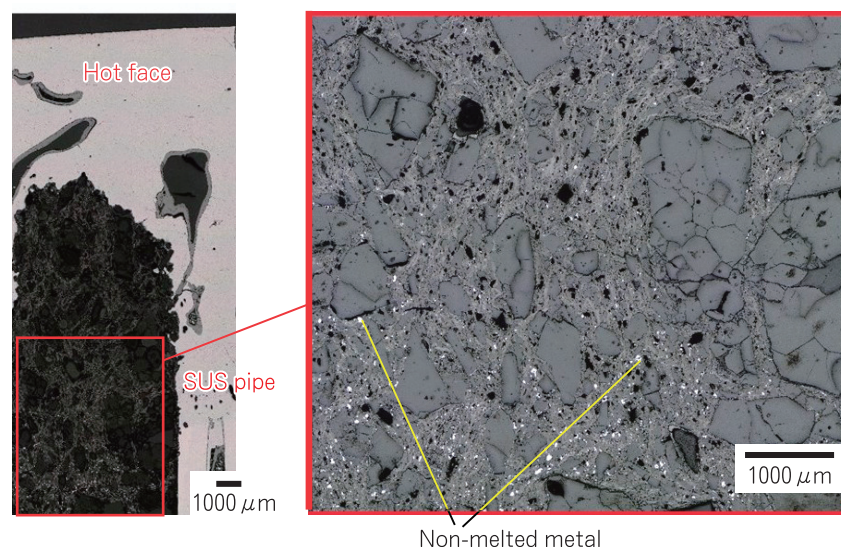
Fig. 7 Magnifying observation result between pipes of used MHP.

A microscopic image of the boundary zone is exemplified in Fig. 7. While high brightness grains, which indicates non-melted metallic additives, were seldom observed within 5mm from the hot face, they were observed frequently at the range of more than 5mm from the hot face. Hence, the boundary can be determined. The temperature distribution was estimated by tracing the boundary through several samples.

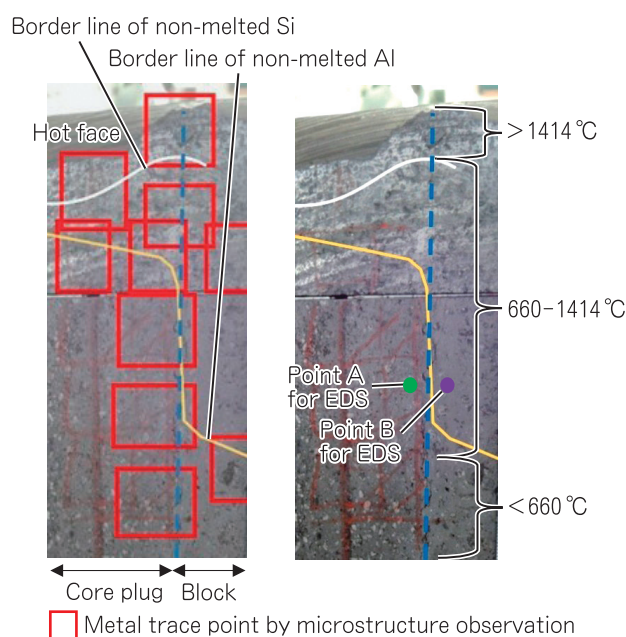
Fig. 8 Metal trace points and border lines of non-melted Al and Si on used MHP cut section.

確認され、ブロック部では稼働面より100mm内部にAlの残存（660℃以下）が確認された。Siが消失している部位（1414℃以上）は稼働面より10～30mm程度であった。また、温度分布線境界での金属熔融判別が適切であるかどうかの確認のためFig.8中のA、B点でエネルギー分散型X線分析（EDS分析）を行った結果をFig.9、10に示す。A

The observed sample-obtained area and determined boundary of non-melted Al and Si are shown in Fig. 8. With respect to the core plug portion, areas including non-melted Al and Si (lower than 660 °C) were observed at 30–50 mm inside the hot face, even at the area without stainless pipes. Regarding the block portion, a non-melted Al-including area (lower than 660 °C) was observed at 100 mm inside from the hot face. The area where the melted Si is distributed (higher than 1414 °C) was within 10–30 mm from the hot face.

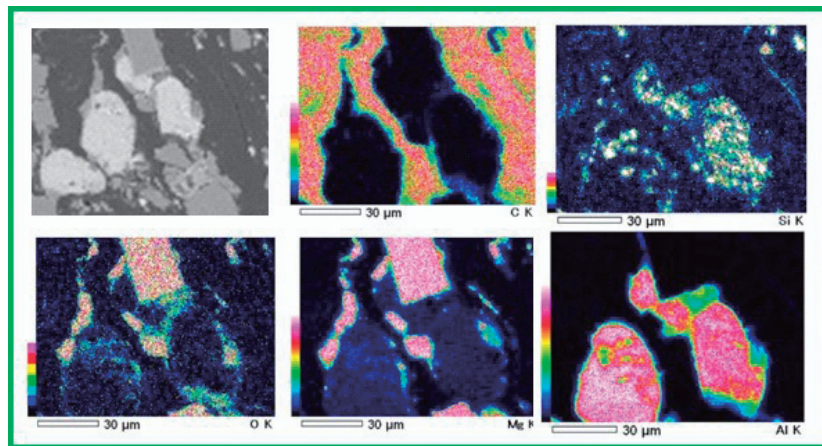
Fig. 9 Result of EDS analysis at point A.

The EDS analysis results at point A and B indicated in Fig. 8, are shown in Figs. 9 and 10, respectively. While a high concentration region of Al was observed at point A, Al was dispersed finely among Mg and O at point B. The high Al concentration region in Fig. 9 is considered to be non-melted Al, taking grain and shape into account. Contrarily, in Fig. 10, the fine Al dispersed texture is considered to be formed by the transfer of molten Al. It ensures the accuracy of the estimation performed by

点ではAl濃度の高い部位が認められるのに対し、B点ではAlがMgやOと混在した様子が確認された。A点のAl濃度の高い部位が金属Alが未溶融で残存している部分であると考えられ、A点は660℃以下であったとの推定と一致している。また、B点ではAlがMgやOと混在しており、A点で見られたAl濃度の高い部位が見られなかったことから660℃以上の温度となりAlが溶融したためと考えられ、推定と良く一致していた。これらの事実より、金属トレースによる温度分布推定は妥当なものであると考えられる。

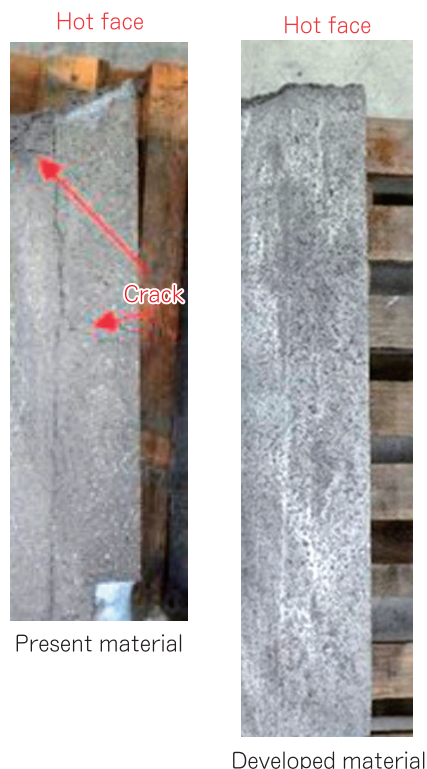
Fig. 17 Cut section of present material MHP and developed material MHP after use.

前項で破壊靱性を比較した3材質について、A製鉄所転炉で使用した際の損傷速度指数の比較をFig.15に示す。なお、指数の元となった損傷速度は使用炉代を問わず各材質の使用終了時点の1ch当りの損傷速度の平均値(N=10)を用いた。従来品と比較し、現行品(MTR品MHP)は約27%損傷速度が改善されており、開発品(MTR-PIB品MHP)は約45%損傷速度が改善された。開発品の使用終了後、炉底表面から撮影した外観写真をFig.16に示す。通常、MHP部分は周囲の炉底れんがよりも大きな損耗を示し局部的に残厚が薄くなる場合がほとんどであるが、開発品は大幅に損傷速度が改善され、Fig.16で見られるようにMHPが使用終了時点まで周辺の炉底れんがと略同一の残厚を維持していた。Fig.17に同一炉代で使用された現行品と開発品の使用後切断面写真を示す。現行品はFig.3やFig.5で見られた稼働面に平行な亀裂の発生が認められたのに対し、開発品は明確な亀裂は見られず、稼働面が芯体部分を起点に滑らかに損傷している様子が観察された。

The cut sections of the MTR technology-applied MHP and the PIB treated MTR technology-applied MHP used in the same campaign are shown in Fig. 17. A crack parallel to the hot face as seen in Figs. 3 and 5 was observed in the MTR technology-applied MHP, but no clear crack was seen and the hot face was worn smoothly starting from the core plug in the PIB treated MTR technology-applied MHP. Hence, it is thought that the main wear factor has been changed from the thermal spalling to the back attack of blowing gas and abrasion by molten steel stream by improving the fracture toughness of MHP.
