Improvement of Steel Casting Ladles

~Extension of Service Life by Application of Unfired Alumina-Magnesia Brick, ALTIMA~

Tetsuyoshi KASAI *¹Yuichi TAKAKURA *²

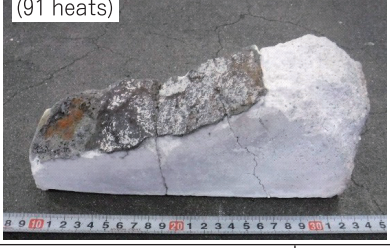
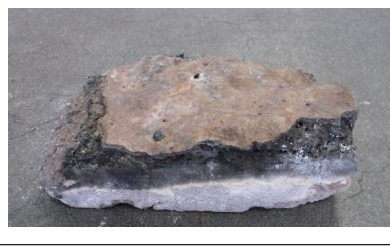
Table 14 Investigation of the bricks after use

ALTIMA for wall of impact area /course 1 (91 heats)	ALTIMA for bottom (41 heats)	LBA-8 for bottom (41 heats)
External appearance

Initial thickness : 114 mm, Target heats : 50 heats Peeling-off occurs. Residual thickness (more than 70 mm) predicts target heats (45) achievement.

Initial thickness : 80 mm, Target heats : 50 heats Peeling-off occurs. Residual thickness (more than 60 mm) predicts target heats (45) achievement.

Initial thickness : 114 mm, Target heats: 90 heats The thinnest point (33 mm) covered by troweling material (30 to 40 mm). 3 troweling repairs after 50 heats.

Table 14 summarizes condition of the bricks after use. ALTIMA was used for the side wall and both ALTIMA and LBA-8 were used for bottom. They were 91 heats and 41 heats, respectively. According to the investigations of these samples, sufficient durability of these bricks was
