# SHINAGAWA TECHNICAL REPORT

# 東日本大震災 被災と復旧

## Recovery of Yumoto Works after East Japan Earthquake Damage

飯 田 栄 司\*  
Eishi IIDA

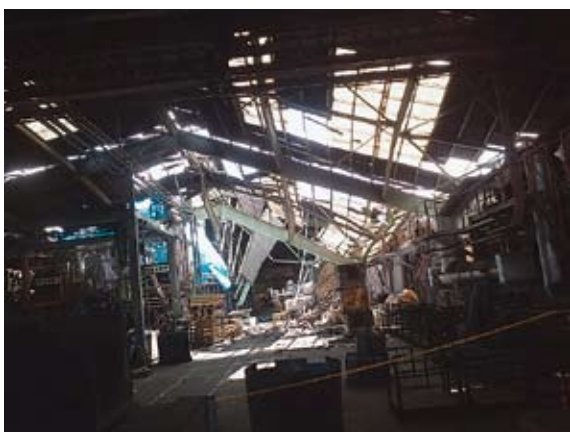
Fig. 1には折損して傾いた煙突の状況を示す。本煙突は全高40mであるが，本震で上部より約22m位置で折損，その後の余震で徐々に傾き，早朝から震度5クラスの余震に3度見舞われた3月23日に倒壊した。Fig. 2には煙突倒壊により大破した工場建屋の状況を示す。また，Fig. 3には本

Fig. 2 Plant building seriously damaged by broke down chimney.

top half fell down on March 23 after several aftershocks of which the seismic intensities were about 5. The appearance of the plant building after the collapse of the chimney is shown in Fig. 2. Fig. 3 shows the appearance of the kiln car traversing pit in which several kiln cars fell down from their stand-by positions.

震災後11日目の3月22日の週からは、管理職、保全部員などを中心に少人数で製品在庫の出荷業務や建屋、設備の復旧作業を再開した。工場内各設備は外観上健全なものから点検、動作確認などを実施。しかしながら、社内の要員のみでは復旧作業に限界があり、土建、建築、電気などあらゆる工事に外注事業者を必要としたが、地元では工事業者自身も被災し、その社員も避難をしている状況で人手不足は深刻であり、復旧作業は困難を極めた。また、本震により折損して傾いた煙突は、安全に解体する方策に全く目途が立たないまま3月23日の余震で倒壊し、周辺の建屋が大破した。

for construction, builders, and electrical engineering but all of those sources were in similar situations. The broken chimney collapsed and destroyed the roof and equipment around it on March 23, even before we could make a concrete plan for dismantling it.

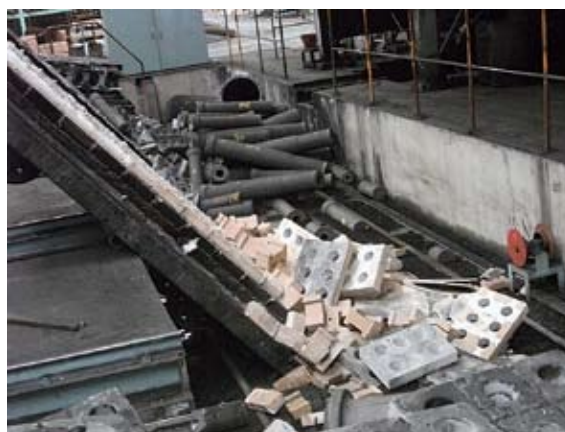
Fig. 3 Kiln car which fell down into traverser pit.

震後、待機位置からトラバースー内に落下した焼成炉台車の状況を示す。

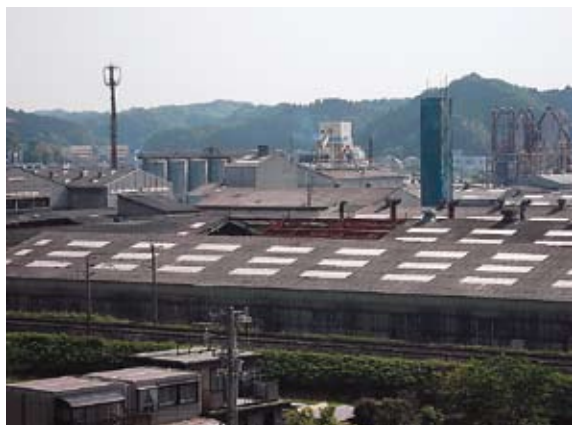
Fig. 4 A distant view of plant under recovery construction.

景を示す。建屋手前の線路はJR常磐線、屋根開口部には復旧中の建屋鉄骨が見える。解体中の煙突はブルーのシートで囲われている。煙突の解体工事がほぼ完了した5月16日からは全ての部署で通常の2シフト体制での操業を再開した。

We had another 40m chimney in the plant, which we dismantled in May to eliminate the concern of aftershocks collapse. A distant view of the plant under the reconstruction and dismantling process of the chimney is shown in Fig. 4. The railway in front of the plant is the Joban Line. The chimney undergoing dismantling work was covered by blue sheets. Two shift working was restarted in all manufacturing sections on May 16 when the dismantling of the chimney was finished.

また、工場内には倒壊した煙突の他にもう1本40m高さの煙突があり、こちらも余震の頻発で倒壊の危険性があり、安全のため解体した。Fig. 4には建屋の復旧と煙突の解体工事が進む工場の遠
