# SHINAGAWA TECHNICAL REPORT

耐剥離性に優れる鍋用  
 $\text{Al}_2\text{O}_3$ - $\text{MgO}$ -Cれんが

$\text{Al}_2\text{O}_3$ - $\text{MgO}$ -C Bricks with High Resistance  
Against Peeling Wear for Steel Ladle

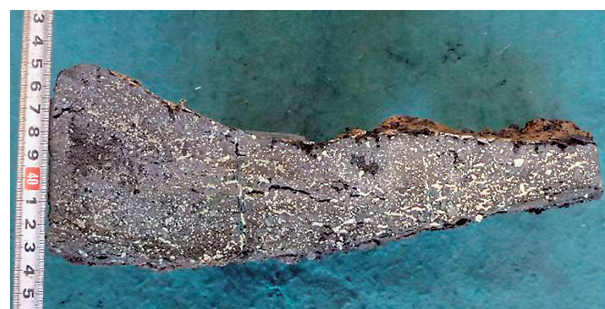
Fig. 2 Cross-section of bricks used in impact zone of steel ladle.

On the other hand,  $\text{Al}_2\text{O}_3$ -MgO-C bricks used in the impact zone occasionally show the structure with a considerable amount of steel penetration among the coarse grains (Fig. 2). In this case, structural spalling, which is caused by the penetration of molten steel into the bricks, was dominant wear factor. We focused on this phenomenon and developed new bricks with a higher resistance to molten steel penetration. The new products showed good performance at many EAF steelmakers.

一方で、実際に湯当たりで使用された $\text{Al}_2\text{O}_3$ -MgO-CレンがではFig. 2に示すように地金がレンが全体に侵入した組織を呈するサンプルが回収される場合がある。したがって、溶鋼の侵入に伴いレンが組織が変質し、構造スポーリングによる剥離が主体で損傷が進行した可能性が考えられる。本報告ではこの点に着目し、溶鋼の侵入対策を行ったレンがを開発・適用したところ電気炉製鋼各社において良好な結果が得られたので報告する。

Fig. 2のような溶鋼侵入組織の形成要因として、溶鋼の落下による衝撃があげられる。直径 $d$ の気孔への溶鋼の侵入は溶鋼の圧力および濡れ性と式(1)で表わされる関係があることが知られており<sup>3)</sup>、溶鋼による圧力 $P$ が大きくなるほど径の小さい気孔に溶鋼が侵入する。

One possible factor causing such an altered structure is impact pressure by molten steel tapped from an EAF as shown in Fig. 2. It is known that penetration of molten metal into a pore with diameter  $d$  is related to pressure and wettability of the molten metal (Eq.1), and an increase of liquid pressure  $P$  reduces the critical pore diameter needed to allow penetration into refractories.

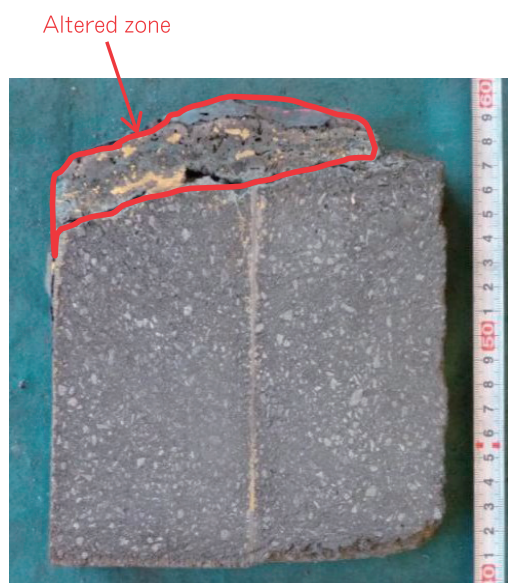
Fig. 5 shows the cross-section of the developed  $\text{Al}_2\text{O}_3$ - $\text{MgO}$ - $\text{C}$  bricks. The bricks were used in the same ladle as the bricks shown in

Fig. 5 Cross-section of bricks used in impact zone of steel ladle.

Fig. 2. The developed bricks showed higher resistance to steel penetration with the thickness of the altered zone in the developed bricks being limited to about 20 mm. Fig. 6 is a comparison of the wear rate between conventional and developed bricks used in the impact zone of

カーで使用した、開発材湯当たりれんがの切断面写真を示す。溶鋼の侵入層は稼働面以深約20mmに止まっており、改善の効果が認められる。また、Fig. 6に電気炉製鋼各社における従来材と開発材の使用結果を示す。多数の電気炉メーカーにおい
