# SHINAGAWA TECHNICAL REPORT

## Improvement of Steel Casting Ladles

～ Extension of Service Life by Application of Unfired  
Alumina-Magnesia Brick, ALTIMA ～

Improvement of Steel Casting Ladles  
～Extension of Service Life by Application of Unfired Alumina-Magnesia Brick,  
ALTIMA～

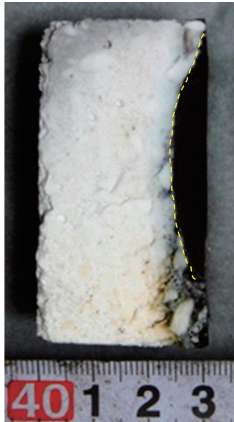
Table 11 Corrosion resistance of well blocks

| | Alumina-Magnesia | High alumina |
|---|---|---|
| | Depth 5.4 mm<br>Index 41 | Depth 13.4 mm<br>Index 100 |

In order to extend the 25 heats service life of conventional high alumina well block, the effect of well block made of alumina-magnesia material AMP-8Y2 was evaluated. Tables 10 and 11 summarize the typical properties and corrosion resistance of well block, respectively.

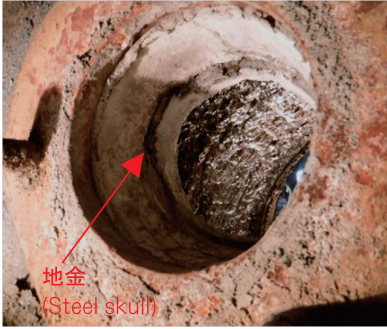
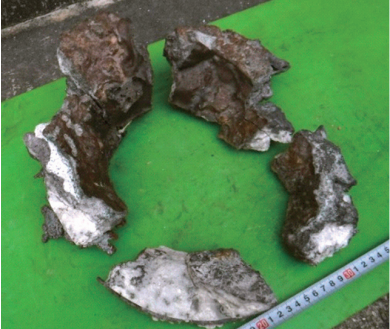
Table 12 Situation of well block after 41 heats

As a result of commercial application, AMP-82Y showed horizontal cracking at a 70 mm height from the back end, which was at the

middle range of its initial thickness of 130 mm as shown in Table 12. As shown in Fig. 4, the cracking occurred at the interface level of the ALTIMA brick and permanent lining.

ノズル受けAMP-8Y2の実炉テスト結果は表12の様に高さ130mmの方向の中間付近(70mm付近)で割れてしまった。図4に示すようにこの割れた部分は鍋の施工位置ではALTIMAれんがとパーマれんがの境界付近になる。

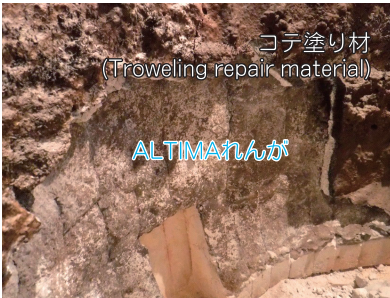
Table 13 Trial result of troweling repair material

In order to repair local corrosion of the impact area, alumina-magnesia troweling material was evaluated as the material for intermediate repair, which is carried out between brick replacing repairs. Table 13 summarizes the test results. Troweling repair material SSC-AM340T is used as paste kneaded with water. As a result of the trial, good workability for installation, which resulted from easy adjustability of the paste softness by controlling the amount of water, as well as sufficient durability, that is, 7 to 8 heats without peeling-off. Accordingly, excellent adhesion during operation was confirmed.

| Impact area wear (50 heats) | Troweling repair | 2 heats after repair (89 to 90 heats) |
|---|---|---|
| Local wear of impact side at course 1 to 2 | 20 kg of troweling repair | Troweling repair material sticks to ALTIMA firmly |

示す。コテ塗り材SSC-AM340Tは水分調整により容易にコテで塗り付けしやすい軟らかさにできて、使用中のれんがによく接着して剥がれることはなく7～8回の耐用を確認できた。

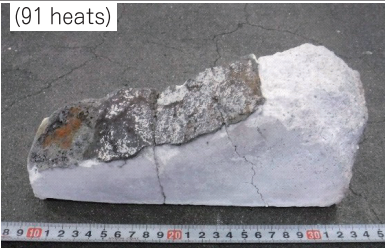
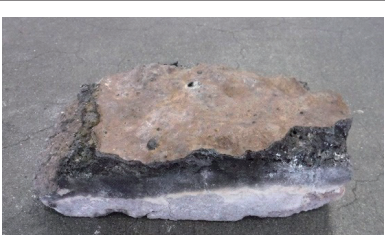
Table 14 Investigation of the bricks after use

Table 14 summarizes condition of the bricks after use. ALTIMA was used for the side wall and both ALTIMA and LBA-8 were used for bottom. They were 91 heats and 41 heats, respectively. According to the investigations of these samples, sufficient durability of these bricks was confirmed.

| | ALTIMA for wall of impact area /course 1 | ALTIMA for bottom (41 heats) | LBA-8 for bottom (41 heats) |
|---|---|---|---|
| Cut section | <br>Initial thickness: 114 mm, Target heats: 50 heats<br>Peeling-off occurs.<br>Residual thickness (more than 70 mm) predicts target heats (45) achievement. | <br>Initial thickness: 114 mm, Target heats: 90 heats<br>The thinnest point (33 mm) covered by troweling material (30 to 40 mm).<br>3 troweling repairs after 50 heats. | <br>Initial thickness: 80 mm, Target heats: 50 heats<br>Peeling-off occurs.<br>Residual thickness (more than 60 mm) predicts target heats (45) achievement. |

側壁ALTIMAの91回、敷ALTIMA及びLBA-8の41回の使用後の状態及び残厚結果を表14に示す。壁は90回以上を、敷は45回を十分に耐用できることを確認した。
