## 加古川 1 RHにおける下部槽寿命の改善\*

### Improvement of Campaign Life of No.1RH Lower Vessel in Kakogawa Works

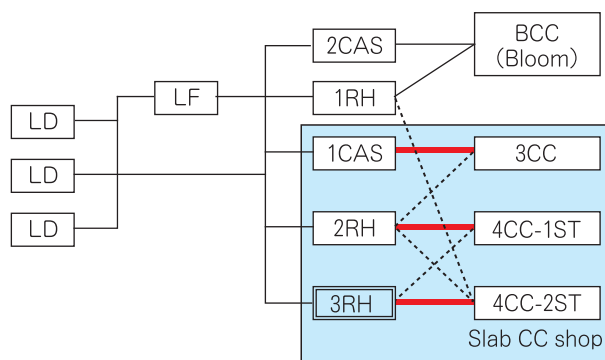
加古川製鉄所では薄板ハイテンなどの高級鋼の増加に対応するべく、No. 3 RH設備を2004年11月に稼働させた。No. 3 RHの稼働により、取鍋精錬プロセスが各連铸機と整合化するようになり、物流が大きく改善された (Fig. 1)。No. 3 RHが稼働するまでは、No. 1 RHでほとんどを処理し

Fig. 1 Change in process flow with No.3RH operation in Kakogawa Works.

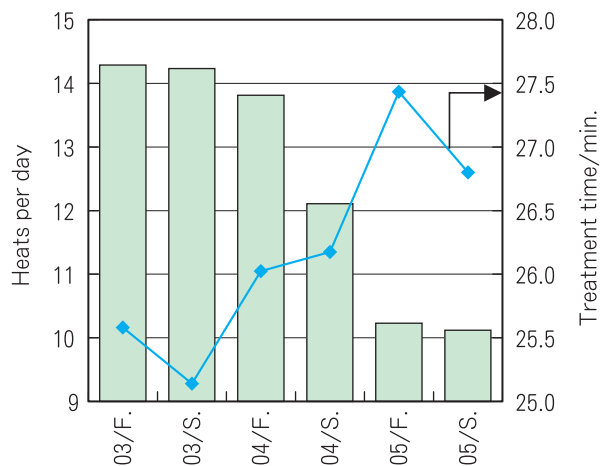
ていた4CC-2ST向け厚板鋼種は、今やそのほとんどがNo. 3 RHで処理されることになった。これに伴い、現在No. 1 RHでは1日あたりの処理チャージ数が減少し、主製品は線材向け鋼種の処理が中心となっている。No. 1 RHの1日当たりの処理チャージ数が減少する一方で、長い時間処理が必要な高級鋼の比率は増加しており、このためNo. 1 RHの平均処理時間は増加傾向にある (Fig. 2)。

Fig. 2 Change in heats per day and treatment time at No.1RH.

Up to the start of No.3RH operation, most plate steel for 4CC-2ST was treated at No.1RH, and now, most of it is treated at No.3RH, therefore, heats per day in existing No.1RH have decreased and the main product of No.1RH has been changed to steel wire rod. Though, heats per day in No.1RH has decreased, the ratio of high-quality steel which requires long treatment time has increased, so the average treatment time in No.1RH has increased. (Fig.2)
