# SHINAGAWA TECHNICAL REPORT

## 転炉MHPの損傷形態の調査と 高靱性化技術適用

Investigation of MHP Wear Pattern for BOF  
and High Fracture Toughness Type MHP

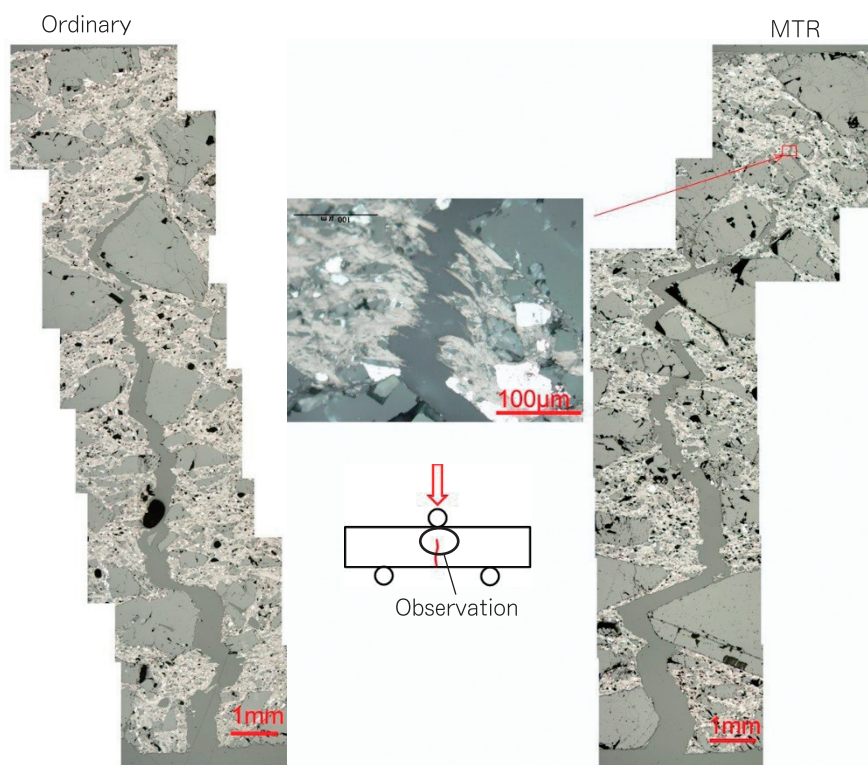
Fig. 11 Crack propagation path observed in MgO-C bricks after bending test.

reinforcement：以下MTRと表現する）することで亀裂の発生，伸展を抑制する，すなわち破壊靱性を向上する手法はMHPの損傷改善にも有効であると考えた。Fig.11に曲げ試験後の試料に観察された亀裂伸展経路を示す。MTR品は，亀裂の伸展がジグザグ状の経路となっており，マクロ的な亀裂の伸展が抑制されている。また，発生した亀裂の伸展は，MgO粒子と黒鉛の間や空隙など，マトリックス組織の弱い部分を繋ぐように伸展している様子が観察され，亀裂の発生，伸展はマトリックス組織の弱い部分を起点としていることが確認できた。

The crack propagation path observed in MgO-C bricks after the bending test is shown in Fig. 11. The zigzag propagation of the crack helps to suppress macroscopic overall crack propagation in the case of the MTR material. Cracks tend to propagate along pores or inter-particle planes between graphite and magnesia, which are considered to be structurally weak positions as observed in Fig. 11.

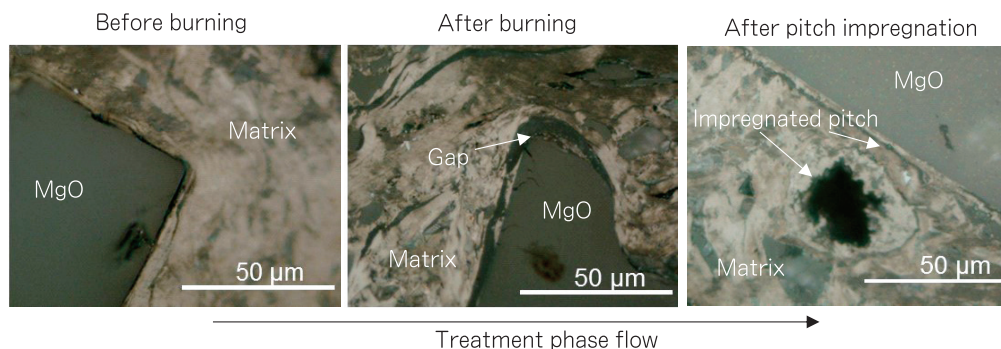
Fig. 12 Microstructure at each phase (before burning, after burning and after pitch impregnation) of pitch impregnation treatment.

さらに靱性を高める手法として，焼成ピッチ含浸処理（Pitch impregnation to the burnt body：以下PIBと表現する。なおマトリックス強化品を焼成ピッチ含浸処理したものは以下MTR-PIBと表現する）をMHPへ適用する手法を用いた。MgO-CれんがのPIBは旧来より存在する処理方法であり，れんがを高温で焼成後に高圧下でピッチを含浸することでれんがの気孔をピッチが埋め，れんがのマトリックス組織を緻密化できる処理方法である。単孔羽口などのPIBは古くから実施されていたものの，MgO-Cれんが中にステンレスパイプを含みかつ大型品であるMHPへのPIBは製造技術上焼成によるパイプの劣化などいくつかの課題が存在した。当社では各課題に対して種々検討を行い，大型MHPへのPIBによる製造方法を確立した。PIBによるれんがマトリックス組織の緻密化について，焼成前後，ピッチ含浸後の各段階の微構造組織写真をFig.12に示す。不焼成れんがであるMgO-Cれんがは焼成時にバインダーやピッチに由来する揮発分の揮発やMgOとCの膨張率差によりFig.12に示されるようにマトリックス組織中に多くの空隙が生成する。焼成後にピッチを高圧下でれんが内部まで含浸処理することによりこれらの空隙がピッチで埋められ，緻密なマトリックス組織が形成されている様子が観察された。

The microstructure of PIB brick at each manufacturing phase as; before burning, after burning and after pitch impregnation, are shown in Fig. 12. Many pores are generated in an unburnt MgO-C brick's matrix due to the volatilization of the volatile matter and the difference of thermal expansion between MgO

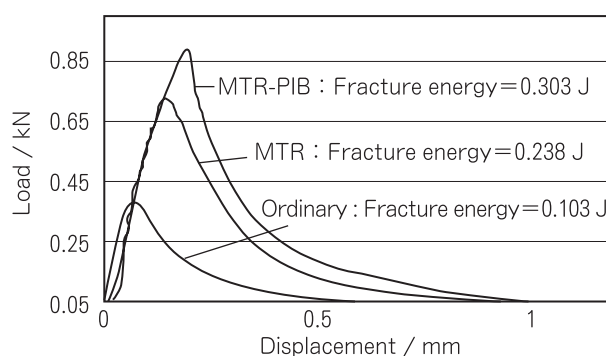
Fig. 13 Load-displacement curves and fracture energy of MgO-C bricks at 800 °C.

Table 1に示す従来材質、MTR材質、MTR-PIB材質について破壊靱性の比較を行うため、800℃における荷重－変位曲線より破壊エネルギーを求めた。なお、試験温度を800℃とした理由は、バインダーであるフェノールレジン炭化後の強度発現（カーボンボンド）がなく、添加金属による強度発現効果が得られ始める前の600～800℃付近の温度域は最もMgO-Cレンガの強度が低下する温度域として知られており<sup>5)</sup>、この温度域が組織評価に適していると考えたからである。測定はAr雰囲気中で3点曲げ試験で行い、スパン100mm、クロスヘッド速度0.1mm/minの条件とした。荷重－変位曲線をFig.13に示す。得られた荷重-変位曲線からそれぞれ測定スパンに応じて曲線を台形近似し測定範囲の曲線面積を求め破壊エネルギーとした。破壊エネルギーは、MTR-PIB材質>MTR材質>従来材質の順に高くなった。次に、MgO-Cレンガの亀裂発生および伸展に関する評価指数として良く用いられる熱衝撃破壊抵抗係数 $R'$ と亀裂安定係数 $R_{st}$ の比較を行った。 $R'$ と $R_{st}$ はそれぞれ下記の

and PIB technology, respectively. The test was performed by three point bending under an Ar atmosphere. The support points were set in the span of 100 mm and the cross head speed was set to 0.1 mm/min. The load-displacement curves are shown in Fig. 13. The fracture energies were obtained by integrating the curves. The fracture energies were high in the order of MTR-PIB > MTR > ordinary material.

In Fig. 13, the initial slope until maximum load was almost equivalent for three materials, while, MRT and MRT-PIB showed larger maximum load and displacement when they fractured. It indicates fracture toughness improvement. Also, improvement can be expected in same order from the results of the comparison of  $R'$  and  $R_{st}$ . According to the above results, it was confirmed that the PIB-treated MTR

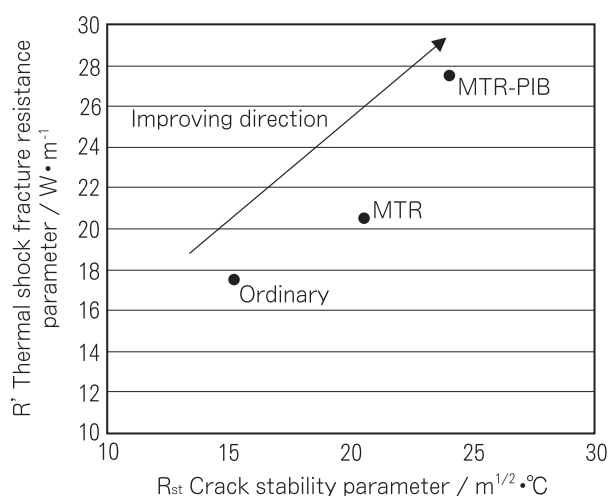
Fig. 14 Comparison of thermal shock fracture resistance parameter and crack stability parameter of MgO-C bricks.

$R_{st}$ を横軸に、 $R'$ を縦軸にとり、3材質の計算値をプロットした図をFig.14に示す。図の右上の領域ほど亀裂の発生、伸展に対して改善が期待される領域を示しており、MTR-PIB材質は従来材質やMTR材質と比較し、 $R'$ 、 $R_{st}$ ともに高い数値を示し右上の改善領域に位置していた。

Where, S,  $\nu$ , k, E,  $\alpha$  and  $\gamma$  indicate fracture strength, Poisson ratio, thermal conductivity, modulus of elasticity, thermal expansion coefficient, and fracture energy, respectively. The higher the  $R'$ , the higher the resistance to crack generation becomes, and the higher the  $R_{st}$ , the higher the resistance to crack propagation becomes. The calculated value of 3 materials was plotted in Fig. 14, wherein the horizontal and vertical axis are  $R_{st}$  and  $R'$ , respectively. The top right corner of the figure shows the improved area for crack generation and propagation. MTR-PIB showed a high value compared with ordinary material and MRT.

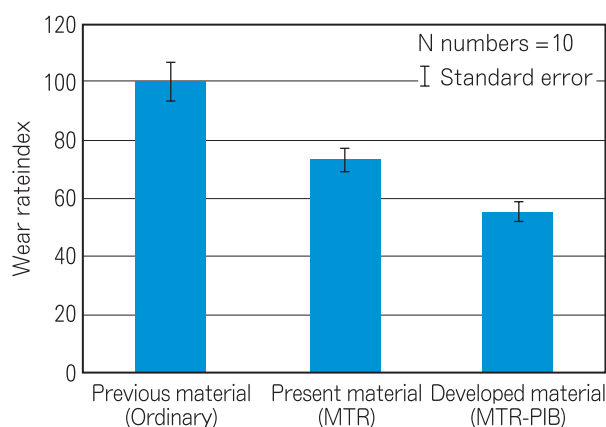
Fig. 15 Comparison of wear rate index of MHPs used in steel mill A.

前項で破壊靱性を比較した3材質について、A製鉄所転炉で使用した際の損傷速度指数の比較をFig.15に示す。なお、指数の元となった損傷速度は使用炉代を問わず各材質の使用終了時点の1ch当りの損傷速度の平均値(N=10)を用いた。従来品と比較し、現行品(MTR品MHP)は約27%損傷速度が改善されており、開発品(MTR-PIB品MHP)は約45%損傷速度が改善された。開発品の使用終了後、炉底表面から撮影した外観写真をFig.16に示す。通常、MHP部分は周囲の炉底れんがよりも大きな損耗を示し局部的に残厚が薄くなる場合がほとんどであるが、開発品は大幅に損傷速度が改善され、Fig.16で見られるようにMHPが使用終了時点まで周辺の炉底れんがと略同一の残厚を維持していた。Fig.17に同一炉代で使用された現行品と開発品の使用後切断面写真を示す。現行品はFig.3やFig.5で見られた稼働面に平行な亀裂の発生が認められたのに対し、開発品は明確な亀裂は見られず、稼働面が芯体部分を起点に滑らかに損傷している様子が観察された。

These materials were applied to a commercial converter at steel mill A. A comparison of the wear rate index of 3 materials is shown in Fig. 15.

By applying the MTR technology, wear rate has been improved approximately 27% compared with the previous material. Moreover, combined application of MTR and PIB technology reduced wear rate approximately 45%. The appearance photograph taken from the bottom surface side of the PIB-treated MTR technology-applied MHP before demolition is shown in Fig. 16. Although MHP often shows higher wear compared with the surrounding bottom bricks and is dented locally, the wear rate of the developed MHP was markedly improved and the developed MHP maintained equivalent residual thickness with the surrounding bottom
