Magnesia Chrome Brick with Superior Erosion Resistance for Secondary Refining Facilities

Abstract

Since one of the typical refractory damage patterns observed in secondary refining facilities is erosion, sufficient erosion resistance is consequently required for magnesia chrome bricks commonly used in secondary refining facilities. Taking into account actual operational circumstances, erosion resistance especially under thermally deteriorated condition A is thought to be more important. A semi-rebonded magnesia chrome brick of which the erosion resistance was improved to have sufficient durability to thermal fluctuations in actual secondary refining operation by means of enhancing the brick's binding structure is introduced in this report.

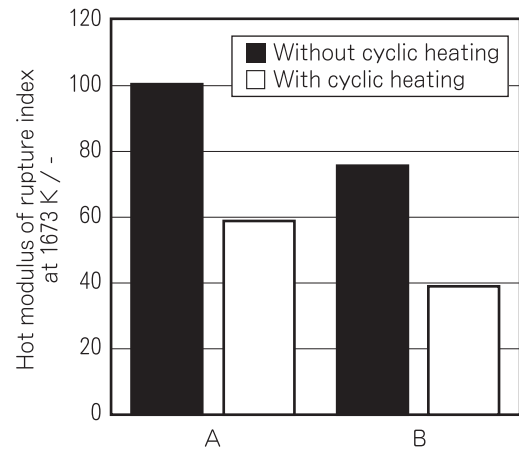
**Fig. 2** HMOR of magnesia chrome brick specimens with and without cyclic heating.

The difference in the binding structure of the two types of magnesia chrome bricks is reflected in the HMOR as well as thermal deterioration resistance. As shown in Fig. 2, magnesia chrome brick A with more enhanced binding structure exhibits higher HMOR than brick B. Since the binding structure in brick is fragmentarily deteriorated by thermal fluctuation³⁾, both bricks exhibited lowered HMOR after cyclic heating. However, better thermal resistance due to the well enhanced binding structure of magnesia chrome brick A is represented by its 40 % HMOR reduction rate, much better than the roughly 48 % HMOR reduction rate of brick B^{3,4)}.

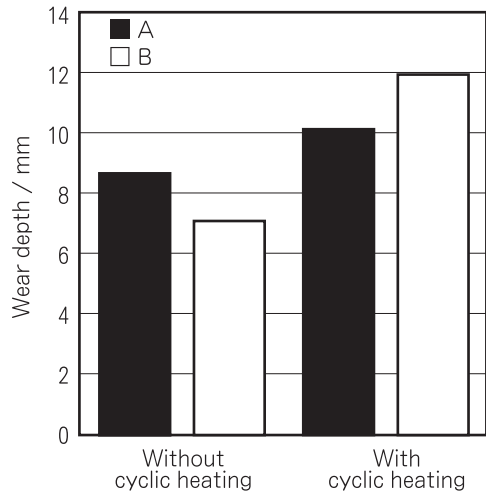
Fig. 4 Wear depth of magnesia chrome brick specimens after erosion test.

The erosion test results are shown in Fig. 4 with the wear depth which was calculated with the specimen dimensions measured before and after the erosion test. In the erosion test on virgin magnesia chrome brick specimens, magnesia chrome brick A exhibited bigger wear depth by 18 %, indicating of its inferior erosion resistance to that of magnesia chrome brick B. In erosion test on magnesia chrome brick specimens after thermal deterioration treatment, however, magnesia chrome brick A exhibits smaller wear depth by 16 % indicating superior erosion resistance under actual operational conditions.

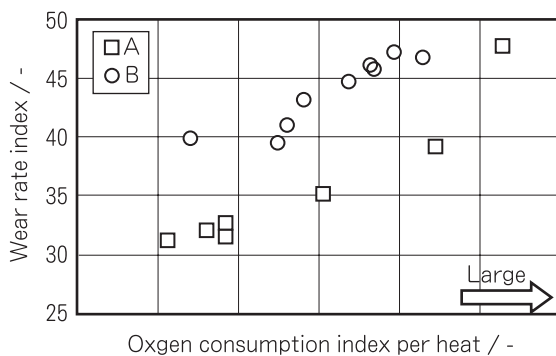
Fig.8 Comparison of wear rates of magnesia chrome bricks A and B relined in lower vessel of RH degasser.

Magnesia chrome brick A and B, both of which were relined in the lower vessel wall of an RH vacuum degassing unit, were compared for the relation between oxygen gas consumption. Wear rate of the relined brick is shown in Fig. 8. Over almost the whole range of oxygen gas consumption, the wear rate of magnesia chrome brick A is smaller than that of brick B by roughly 20 %. Micrographs of the microstructure near the hot face of magnesia chrome brick A and B retrieved after campaign life are shown in Fig. 9, in which the actual hot face is similarly indicated with a dotted line. Coarse particles
