# 高耐用SVプレート

## High Performance Slide Gate Valve Plate

### Abstract

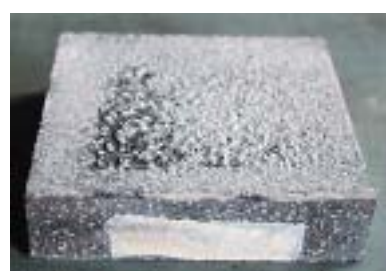
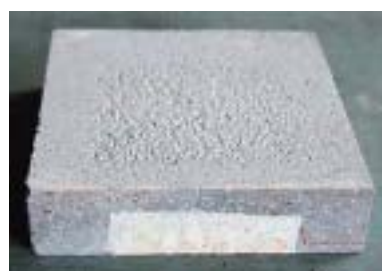
Conventional

Developed

**Fig. 1** Samples after hot abrasion test.

脱炭後組織の脆化度を評価するために熱間摩耗試験を実施した。Table 1 に試験に供した開発品 (C=5%) と当社従来品 (C=7%) の品質表を示す。試験は900℃酸化条件で0.5～1.5mmのアルミナ粒をサンプルに吹付けて実施し、試験後の摩耗体積を測定した。試験後のサンプルの外観写真をFig. 1 に、摩耗体積を指数化して比較したグラフをFig. 2 に示す。外観写真から、従来品の試験後サンプル表面では脱炭層が摩耗されて黒い原煉瓦組織が剥き出しになっている部分が見られるが、開発品では脱炭層が残っており脱炭後組織が強化されていることがわかる。摩耗体積を比較しても開発品の耐摩耗性が優れていることがわかる。

The deterioration of the decarbonized layer was evaluated by the hot abrasion test. The conventional plate material (C=7%) and newly developed SV plate material (C=5%) were tested and their properties are shown in Table 1. Samples were sprayed with granular alumina (grain size = 0.5 ~ 1.5mm) under oxidation conditions at 900℃, and we measured the abraded volume of samples. Fig.1 shows the appearance of the samples after the hot abrasion test, and Fig.2 shows the comparison of index numbers of the abraded volumes of both samples.

On the surface of the conventional SV plate material, the decarbonized layer was abraded and unoxidized black material appeared. On the other hand, the decarbonized layer remained on the newly developed SV plate material is indicating that it was strengthened. A comparison of the abraded volume of the samples also shows that the newly developed SV plate material has good abrasion resistance.

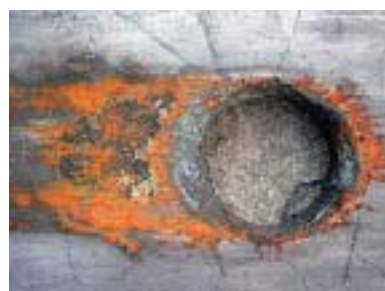
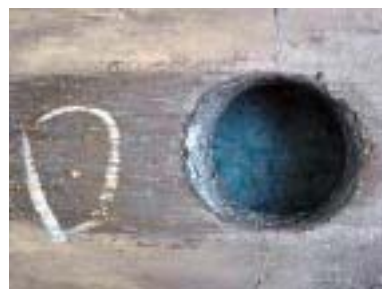
Conventional

Developed

Fig. 4 Sliding surface damage of conventional and newly developed plates after used.

従来品と開発品の代表的な損傷状況をFig. 4 に示す。従来品では脱炭層の剥がれによると推測される面損傷が見られるが、開発品は面損傷が軽微である。これは低カーボン化による脱炭後組織の強化が面損傷の抑制に寄与し

The results of field trial of the newly developed material in a 270t ladle SV plate will be described below. Fig.4 shows the representative damage forms of the newly developed and conventional plate materials. Sliding surface damage by peeling of decarbonized layer is seen on conventional plate material but little sliding surface damage is seen on the newly developed plate material. It is supposed that the dense texture of the decarbonized layer created by decreasing carbon content made it possible to suppress sliding surface damage. Fig.5 shows a comparison of sliding surface damage indexes between the newly developed and conventional SV plate material. Sliding surface damage of the newly developed SV plate material was improved.
