# SHINAGAWA TECHNICAL REPORT

## コークス炉用耐火物の損傷

### Damage of Coke Oven Refractories

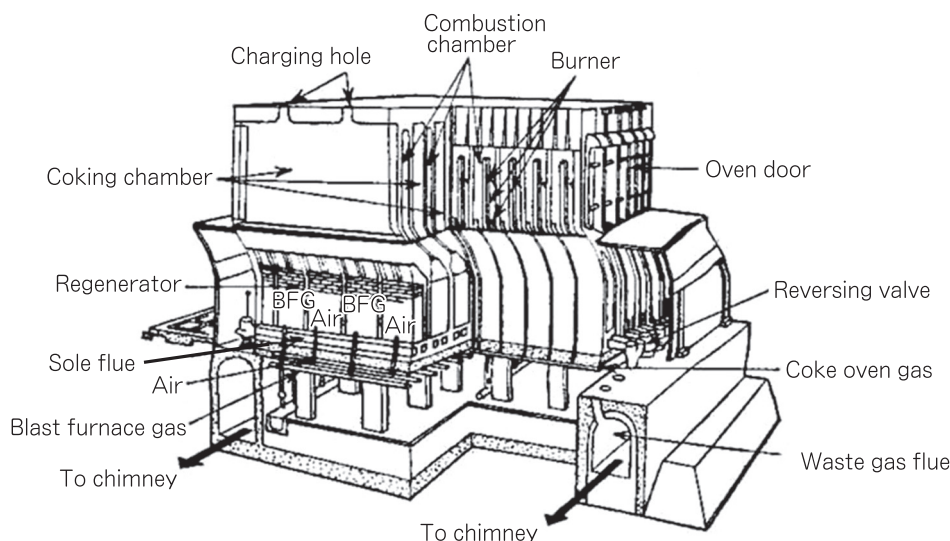
Fig.1 Structure of coke oven<sup>1)</sup>.

室炉式コークス炉は、石炭を高温で乾留しコークスを製造する窯炉である。Fig.1にコークス炉の構造を概略で示す<sup>1)</sup>。コークス炉の炉体は炉頂から石炭を受け入れ乾留する炭化室と、燃焼により高温ガスを作り出す燃焼室が交互に配列されている上部構造体と、排熱回収のための蓄熱室のある下部炉体とで構成されている。コークス炉には、日鉄式、コッパース式、カールスチール式、オートー式、ウイルプット式、D.K.H（デイデア・カールスチール）式など種々の形式がある<sup>2)</sup>が、炭化室、燃焼室と蓄熱室の配置は同じであり、異なるところは燃焼方式と蓄熱方式である。高温の燃焼室の熱は壁煉瓦を介して炭化室側の石炭に伝えられ、石炭を乾留する。乾留終了後に、炭化

The chamber type coke oven is a facility to manufacture coke by coal coking, i.e., carbonization, at a high temperature. Fig.1 schematically shows the coke oven structure<sup>1)</sup>. The body of the oven consists of an upper part for coal coking and lower part for exhaust heat recovery. On the upper part, coking chambers, in which coal is charged through a charging hole installed on the roof carbonized, and combustion chambers, which generate high temperature gas, are arranged alternately. There are several kinds of chamber type coke ovens such as the Nippon steel type oven, Koppers type oven, Carl Still type oven, Otto type oven, Willpute type oven, D.K.H (Didier Carl Still) type oven, and so on<sup>2)</sup>. In spite of the difference in combustion and heat

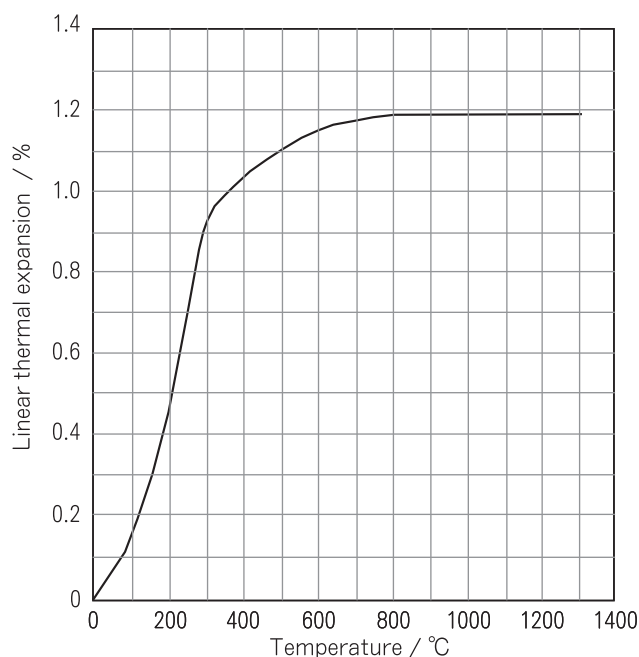
Fig.2 Thermal expansion of silica brick<sup>5)</sup>.

依存性がFig.2に示す<sup>5)</sup>とおり、低温域では大きいですが、1073K以上ではほぼ一定で、高温域での寸法安定性に優れている。さらに高温強度が大きく、耐摩耗特性に優れており、前述のとおり高温部に使用されている。

clay bricks, coking chamber, combustion chamber and upper part of regenerator-silica bricks, wall of lower part regenerator and sole flue-fire clay brick, upper part of checker-silica brick or high alumina brick, lower part of checker-fire clay brick, oven door-fire clay brick or fire clay precast block and ascension pipe-fire clay castable or fire clay brick. Among those, silica brick is applied to the high temperature area because of its excellent volume stability and abrasion resistance, i.e. high strength, at high temperature range. As shown in Fig.2<sup>5)</sup>, silica brick exhibits almost no thermal expansion above 1073K in spite of a large thermal expansion coefficient at lower temperature.

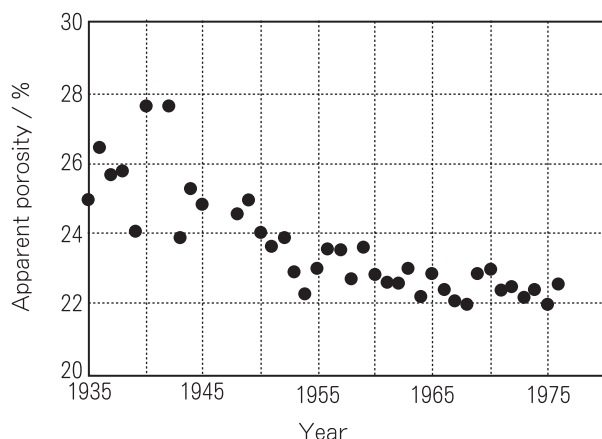
Fig.3 Apparent porosity of silica brick for coke oven<sup>7)</sup>.

Silica bricks were used for open-hearth furnace as well, thus, domestic production of silica brick was carried out in order to ensure a stable supply. As a result, good silica bricks were obtained by using red and white-speckled silica, which contained 97.0% SiO<sub>2</sub>, 0.5% Al<sub>2</sub>O<sub>3</sub> and 2.0% Fe<sub>2</sub>O<sub>3</sub><sup>9)</sup>, as a raw material. These bricks were subsequently replaced with imported bricks. After that, according to the requirements for chamber enlargement and coking time reduction, silica brick had been substantially improved so as to achieve high density and high strength bricks by optimizing raw material application and grain size distribution as shown in Figs.3<sup>7)</sup> and 4<sup>7)</sup>. Consequentially, the so-called dense

によりFig.3<sup>7)</sup>, 4<sup>7)</sup>に示すとおり, 年々緻密化, 高強度化が図られており, いわゆるDense silica brick, Super-dense silica brickと呼ばれる珪石煉瓦が使用されるようになった。大正から昭和初期にかけて, コークス炉の炉高は4mが標準的であったが, 生産量増大の要求ともあいまって, 1961年新日鐵・室蘭で4.6m炉, 1964年川鉄化学・千葉で6m炉, 1967年川鉄化学・水島で6.5m炉, 1971年住金化工・鹿島で7.125m炉, 1976年NKK・京浜で7.55m炉と順次大型化が進展した<sup>2)</sup>。しかし, 1970年代までのコークス炉建設が終わると, 後述する補修技術の進歩もあり, 国内でのコークス炉新設は途絶え, 国内での珪石煉瓦製造はほとんどなくなった。最近になり, 新設や後述するパドアップによる炉の建て替えが行われるようになってきたが, 中国等

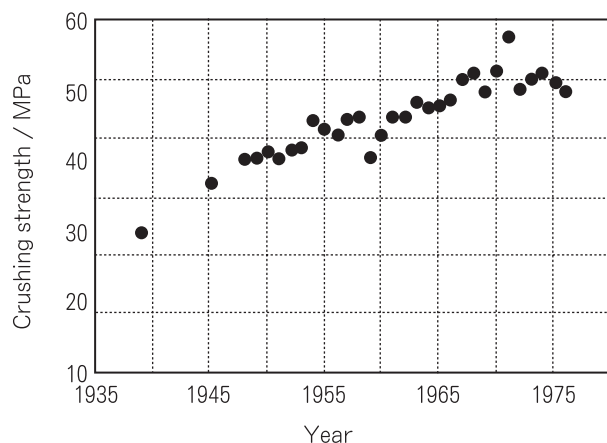
Fig.4 Crushing strength of silica brick for coke oven<sup>7)</sup>.

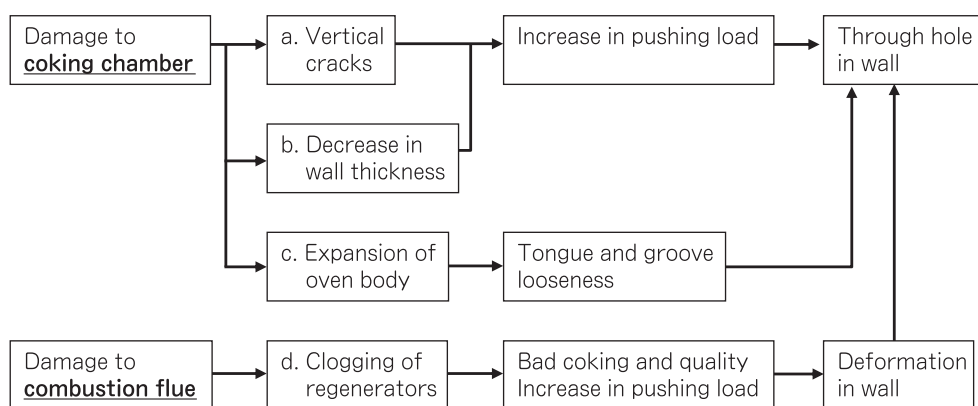
Fig.5 Schematic flow of coke oven deterioration<sup>10)</sup>.

Figs.5<sup>10)</sup> and 6<sup>10)</sup> show the classification system and typical examples of coke oven damage, respectively. According to the approximately 24 hour coke production cycle, i.e., from coal charging through the charging hole to coke discharging into the quenching car, the temperature of coking chamber wall repeatedly changes. Fig.7 is an examples of the measured change in temperature in one cycle<sup>11)</sup>. While silica bricks for the coke oven exhibit superior volume stability due to an extremely small thermal expansion coefficient at high temperatures of over 1073K, it shows a large thermal expansion coefficient at the lower temperature range as mentioned above. Hence, cracking, surface peeling-off and joint opening occur during the earlier stages of oven operation around the chamber end which tends to be cooled by fresh air during coke discharging. In addition, after long term operation, cracking, peeling-off and joint defects caused by thermal shock corresponding to coking cycles are recognized even at the central area of the coking chamber. In interstices induced by cracking and/or joint defects, carbon tends to deposit, resulting in crack propagation during coking

境田ら<sup>10)</sup>によるコークス炉の損傷形態の分類をFig.5に、典型例をFig.6に示す。炉頂の装炭孔より装入した石炭を乾留・コークス化し、それをP/Sより押出しでC/Sの消火車へ排出する一連のサイクルは、約24時間ピッチで繰り返される。この時の炭化室壁の温度変化の一例をFig.7に示す<sup>11)</sup>。珪石煉瓦は、前述のとおり、1073K以上の高温域では

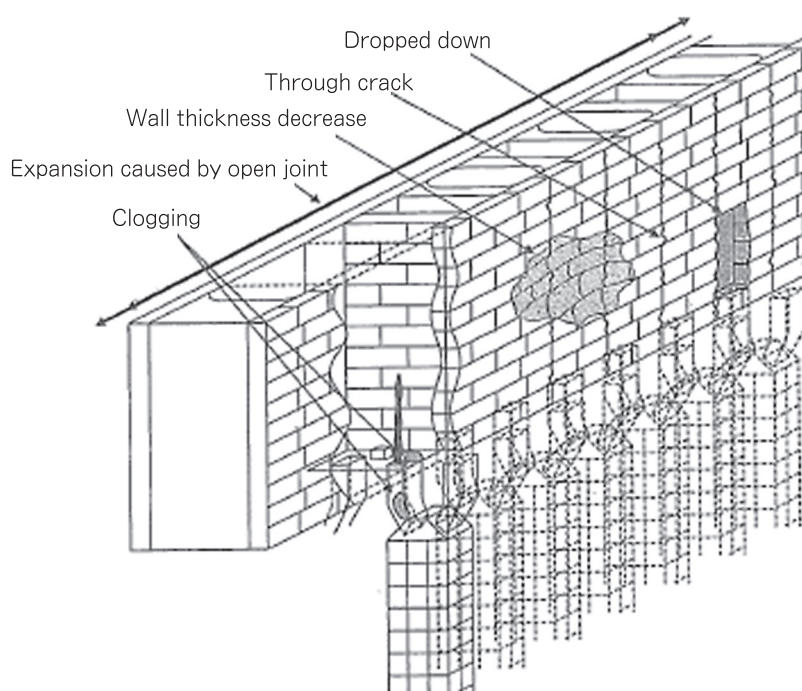
Fig.6 Typical damage pattern of chamber brick<sup>10)</sup>.

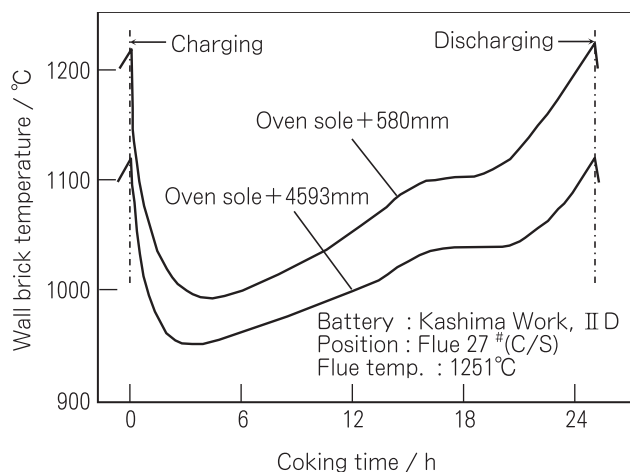
Fig.7 Change of wall brick temperature with coking time<sup>11)</sup>.
